Berryman

November 20, 2018

**Re: Robert Walker and Brandy Newsom,
Plaintiffs
v.
USAA Casualty Insurance Company,
Defendant
United States District Court
Western District of Oklahoma
Case #: CIV-17-752-D**

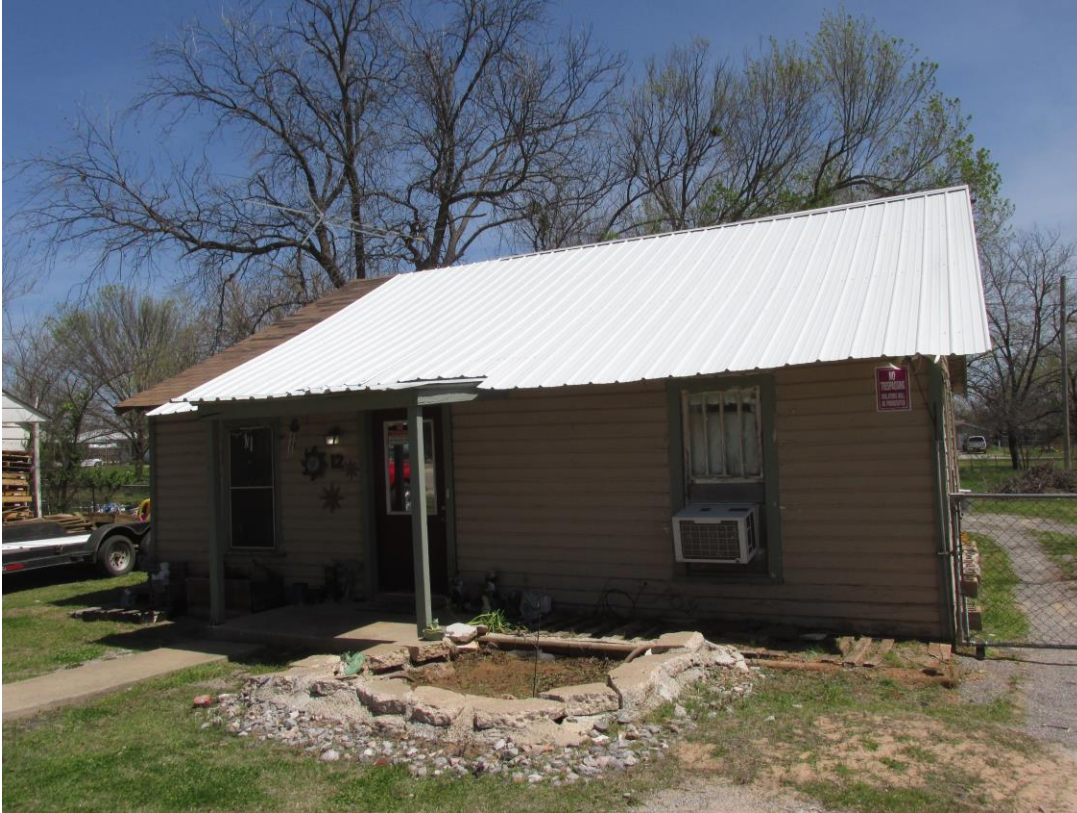
The subject property is a one level, single family residential structure owned by the Walkers. Based upon information and belief, the home was built in approximately 1930 and has 908 SF, more or less. It appears to be wood framed construction situated over an earthen crawlspace, the exceptions being the main living area and rear utility room which are supported by a cast-in-place concrete foundation and slab-on-grade. The exterior cladding of the home consists of painted wood siding. The roof structure is constructed with dimensional lumber and covered with asphalt composition shingles overlaid by metal roofing sheets. Generally, the home faces west.
